# PHASE 1 MILESTONE INSPECTION REPORT

**650 ISLAND WAY CONDOMINIUM ASSOCIATION, INC**

650 Island Way, Clearwater, FL 33767

March 27, 2024

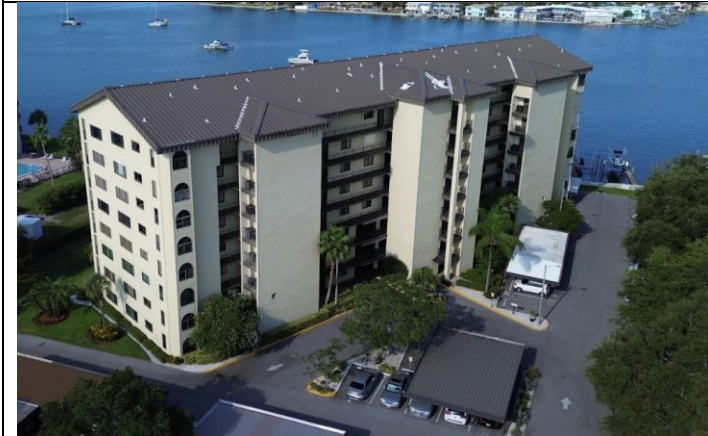
2. Roof Overview

Roofing is a standing seam metal system. Observed numerous prior sealant repairs to roof via drone.

**No concern of note at time of inspection.**

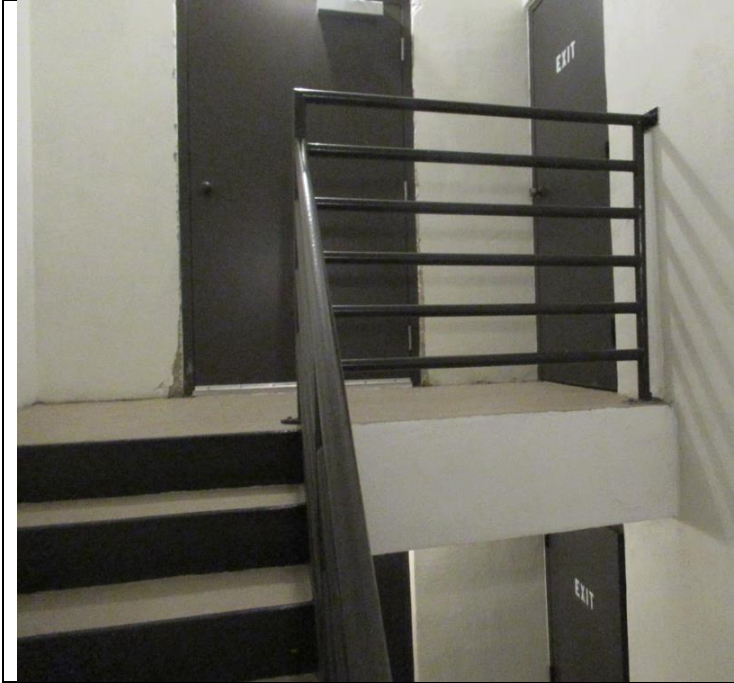
5. Stairwell Overview  
(typical)

**No issues observed.**

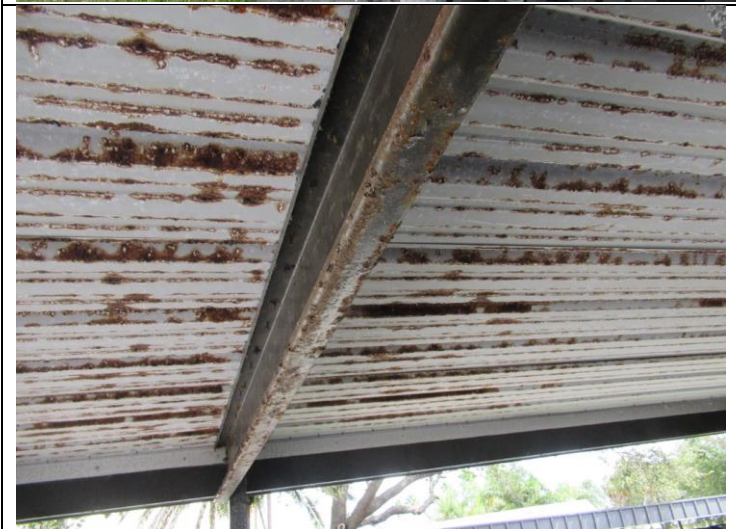
Observed severe rusting on the northwest and center west carports. We recommended continuous monitoring and to plan for repair within next 3 years.

11. Observed severe rusting along Northwest and Center West Carports. (Continuous Monitoring Recommended)

- 4.1 Due to the age and condition of the Northwest and Center west Carports, we recommend yearly site inspections to monitor their condition. As well as planning for future repair
- Substantial structural damage.
  - Dangerous or unsafe condition.
  - Damaged, repair recommended.
  - Damaged, requiring repair.
  - Continuous monitoring recommended.
