# PHASE 1 MILESTONE INSPECTION REPORT

**650 ISLAND WAY CONDOMINIUM ASSOCIATION, INC**

650 Island Way, Clearwater, FL 33767

March 27, 2024

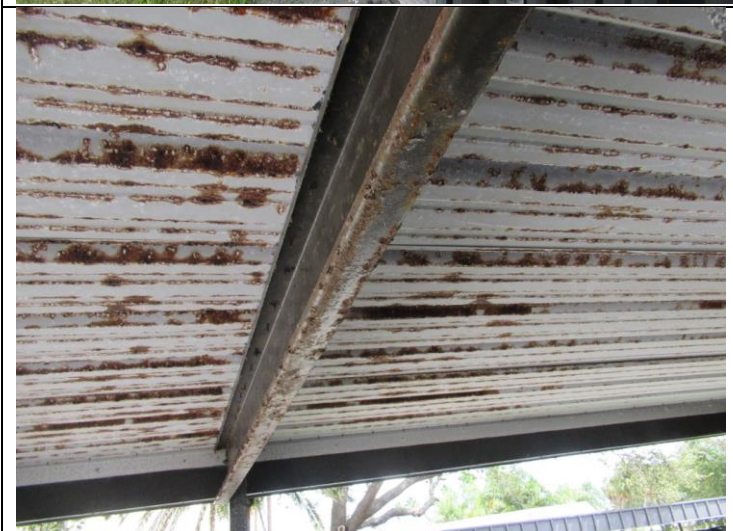
- Observed severe rusting along the Northwest and Center west Carports. Continuous monitoring recommended, with immediate repair if further degradation occurs.

Observed severe rusting on the northwest and center west carports. We recommended continuous monitoring and to plan for repair within next 3 years.

11. Observed severe rusting along Northwest and Center West Carports. (Continuous Monitoring Recommended)

- 4.1 Due to the age and condition of the Northwest and Center west Carports, we recommend yearly site inspections to monitor their condition. As well as planning for future repair
- Substantial structural damage.
  - Dangerous or unsafe condition.
  - Damaged, repair recommended.
  - Damaged, requiring repair.
  - Continuous monitoring recommended.
