COMMERCIAL WINDSTORM MITIGATION REPORT (OIR-B1-1802)

650 Island Way Condominium Association, Inc.

650 Island Way, Units 101-708, 801-804

As of 5/1/2020

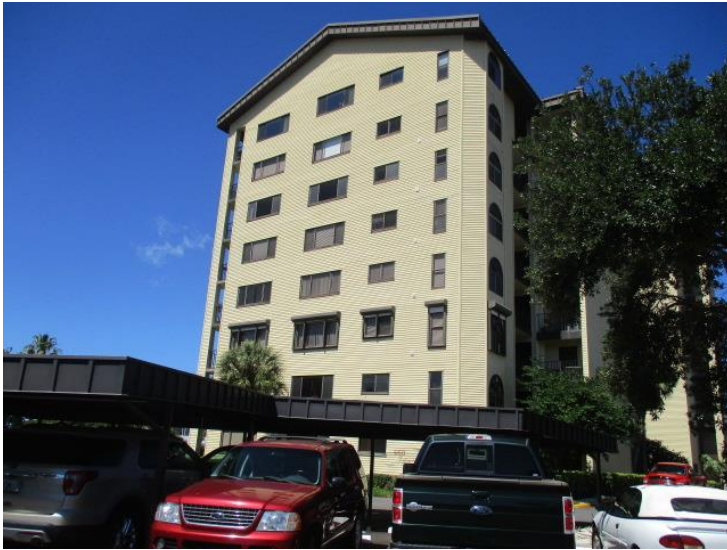
Exterior Elevation

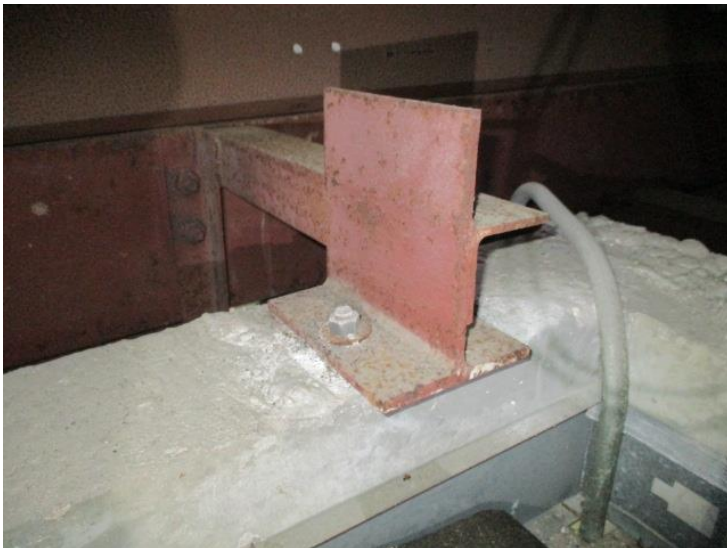
| 4. <u>Roof to Wall Attachment:</u> Comments: | Structural Inspection verified anchor bolts structurally attaching steel rafters to steel girders. |
| 5. <u>Roof Geometry:</u> Comments: | Other Roof Inspection verified a gable roof shape. |

Roof Construction
