COMMERCIAL WINDSTORM MITIGATION REPORT

650 Island Way Condominium

COMMERCIAL WINDSTORM MITIGATION REPORT (OIR-B1-1802)

COMMERCIAL WINDSTORM MITIGATION REPORT (MIT-BT II & III)

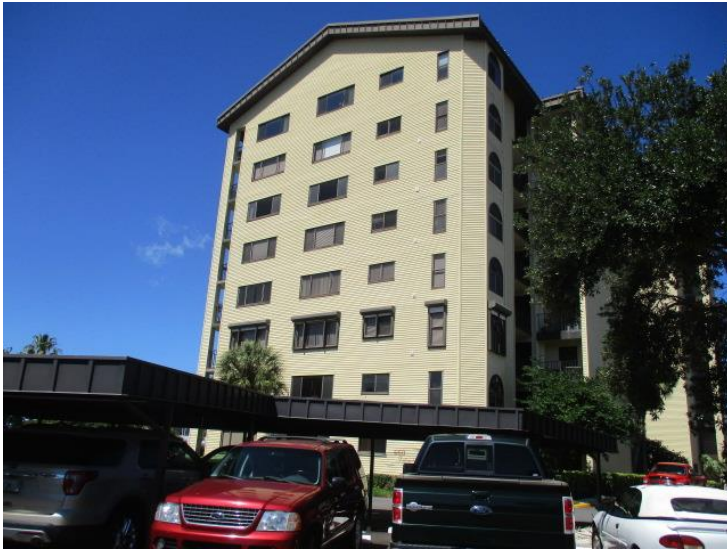
Exterior Elevation

- 1. Building Code:** **Unknown or does not meet the requirements of Answer A or B**
Comments: The year of construction was verified as 1988 per Pinellas County Property Appraiser.

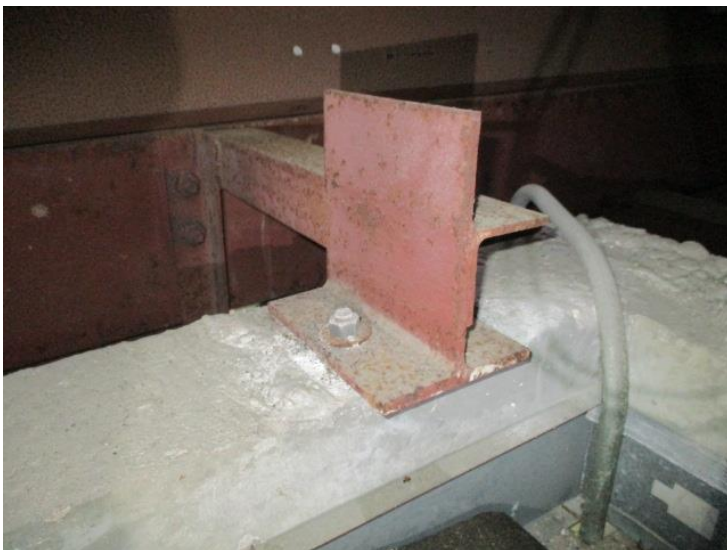
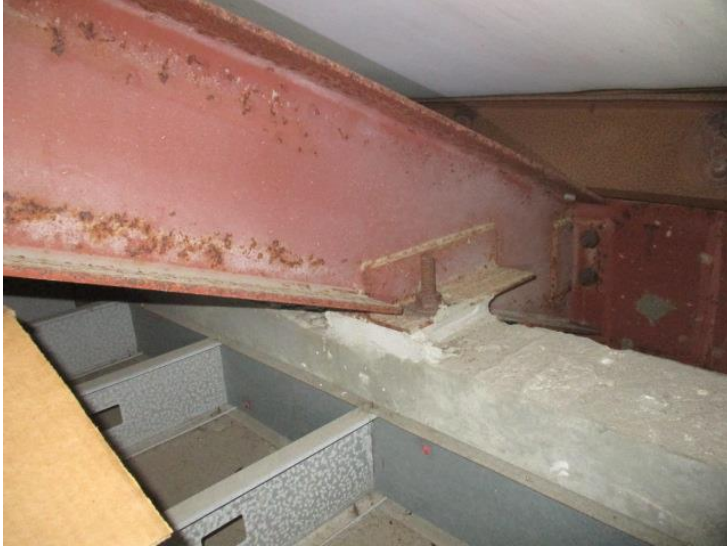
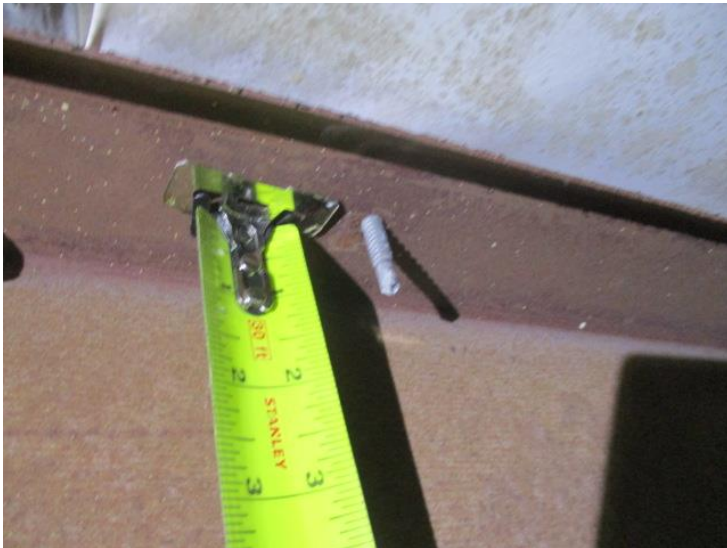
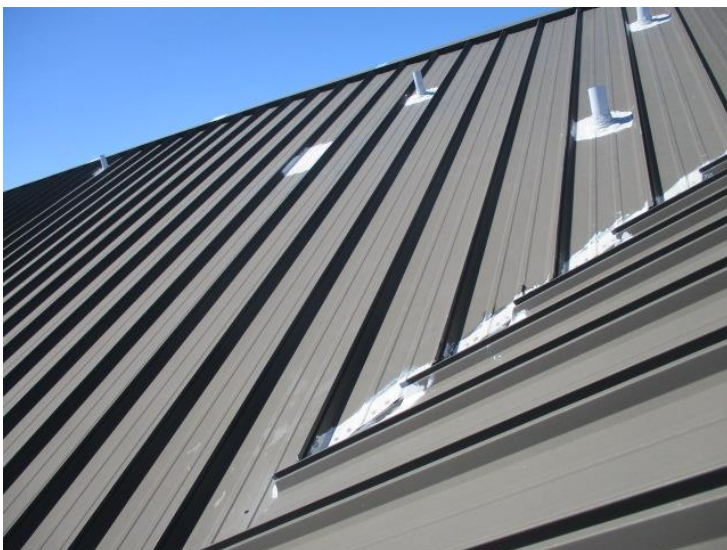
Roof Construction

- 2. Roof Covering:** **No roof coverings meet the minimum requirements**
Comments: The roof covering was installed with the original construction of the building in 1988, not meeting the requirements of the mitigation affidavit. The OIR-1802 mitigation affidavit requires all roof coverings to be permitted on or after March 1st 2002 to receive credit. This roof was verified as not meeting the requirements outlined on the mitigation affidavit.

- 3. Roof Deck Attachment:** **Unknown or Unidentified**
Comments: We were unable to determine the roof deck attachment at the time of inspection.
- 4. Roof to Wall Attachment:** **Structural**
Comments: Inspection verified anchor bolts structurally attaching steel rafters to steel girders.

- 5. Roof Geometry:** **Other Roof**
Comments: Inspection verified a gable roof shape.
- 6. SWR:** **No**
Comments: No SWR verified.
- 7. Opening Protection:** **None or Some Glazed Openings**
Comments: Inspection verified some metal shutter opening protection. Not all glazed openings were protected with impact resistant coverings.

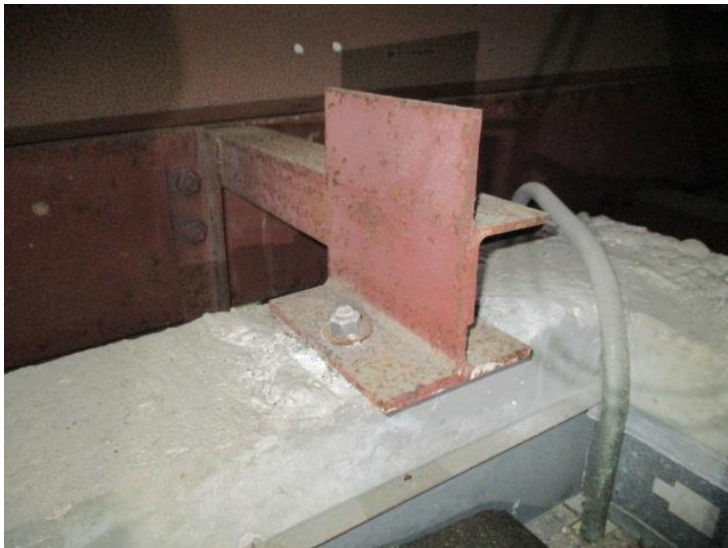
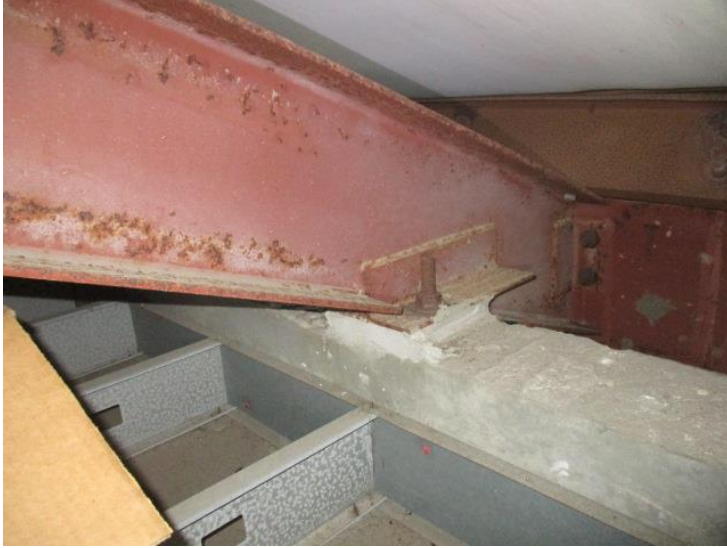
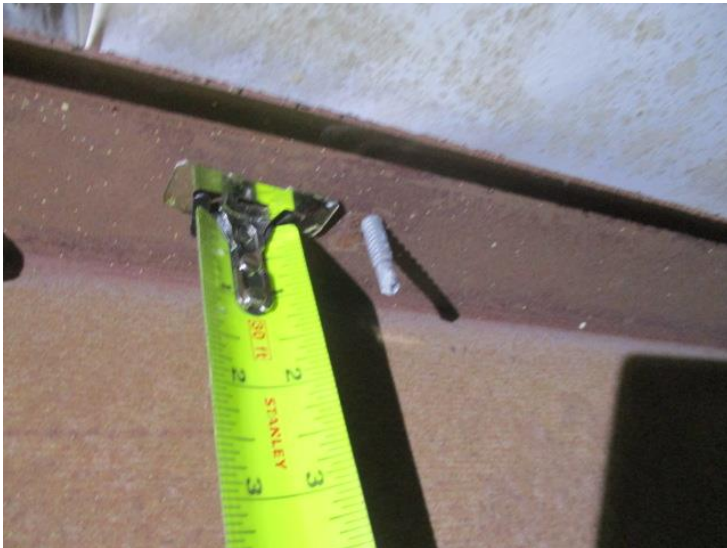
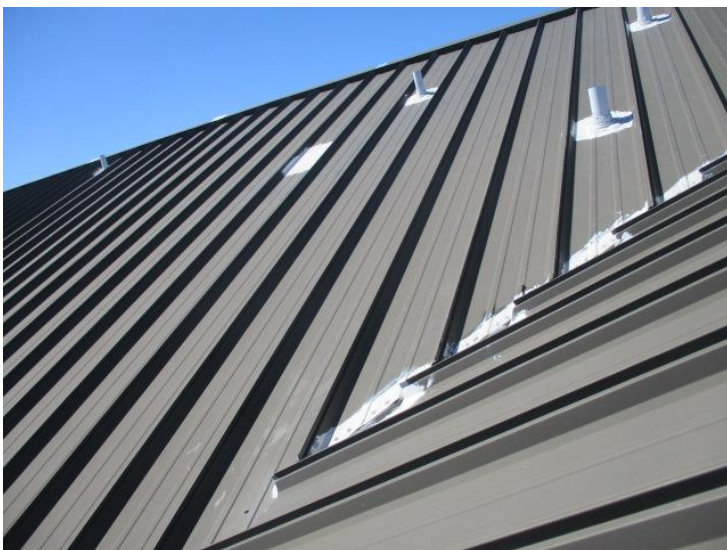
Roof Construction

- 1. Roof Covering:** **No roof coverings meet the minimum requirements**
Comments: The roof covering was installed with the original construction of the building in 1988, not meeting the requirements of the mitigation affidavit. The OIR-1802 mitigation affidavit requires all roof coverings to be permitted on or after March 1st 2002 to receive credit. This roof was verified as not meeting the requirements outlined on the mitigation affidavit.
- 2. Roof Deck Attachment:** **Unknown or Unidentified**
Comments: We were unable to determine the roof deck attachment at the time of inspection.
- 3. SWR:** **No**
Comments: No SWR verified.
- 4. Opening Protection:** **None or Some Glazed Openings**
Comments: Inspection verified some metal shutter opening protection. Not all glazed openings were protected with impact resistant coverings.
