# PHASE 1 MILESTONE INSPECTION REPORT

**650 ISLAND WAY CONDOMINIUM ASSOCIATION, INC**

650 Island Way, Clearwater, FL 33767

March 27, 2024

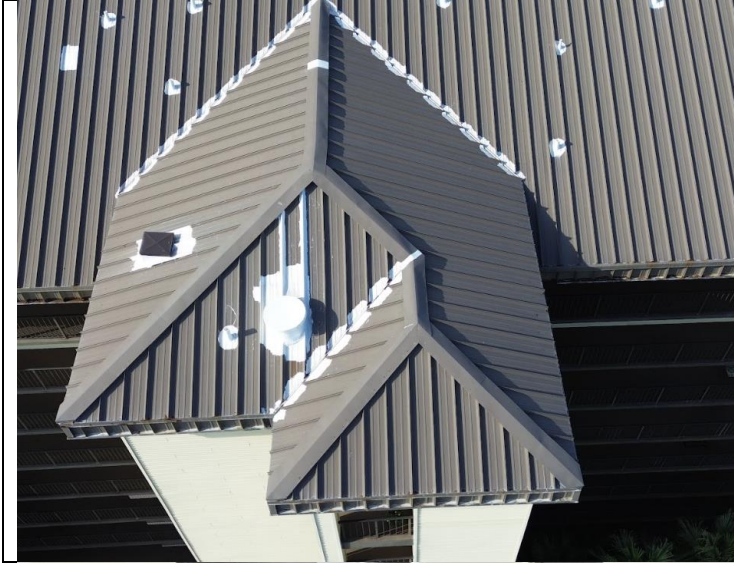
4. Roof Overview Closeup

Roofing is a standing seam metal system. Observed numerous prior sealant repairs to roof via drone.

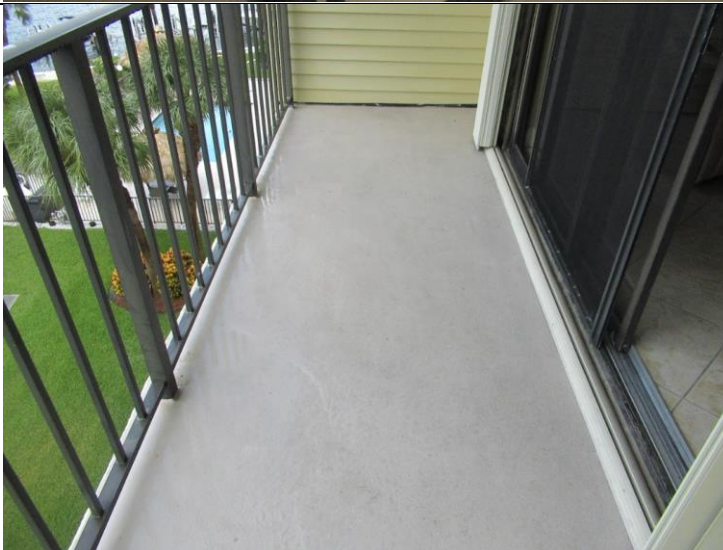
7. Unit Balcony Overview

**All issues of notes have since been repaired.**

We recommend that these issues be periodically monitored for further degradation. If repairs are completed EIRS will be required to provide oversight to ensure the correct material is used in the repairs.
